**TECHNICAL DIAGNOSTIC
FLAT ROOF SURVEYS**

TECHNICAL ROOF DIAGNOSTICS

Pinpointing precise areas of water ingress on existing flat roofs

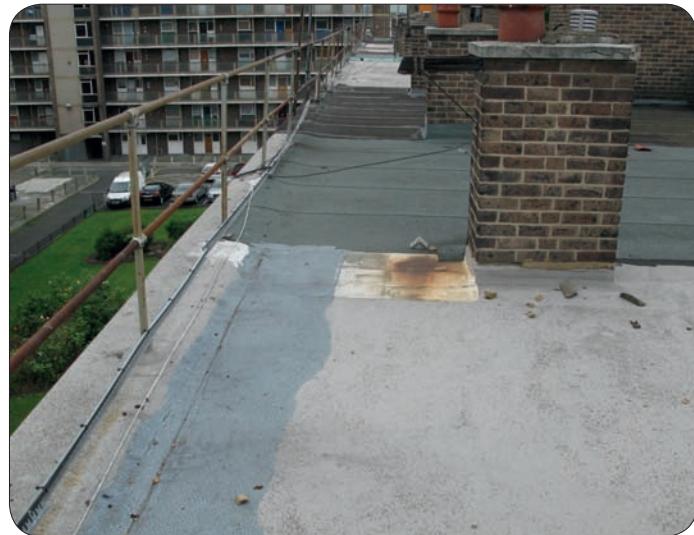
Daytime observation of a roof area at Shaftesbury Court with no apparent signs of water ingress.
